# INSPECTION REPORT

For the Property at:  
**664 SLEEPY HOLLOW LN**  
HOLLAND, MI 49423

Prepared for: BRENT SHOEMAKER  
Inspection Date: Wednesday, April 10, 2013  
Prepared by: Brent Shoemaker

RE: Report No. 1003, v.2  
664 Sleepy Hollow LN  
Holland, MI  
49423

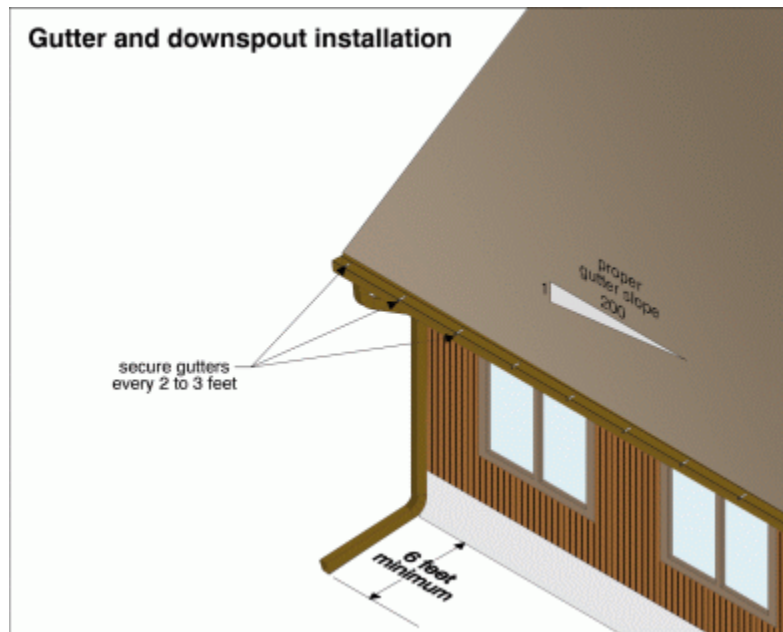
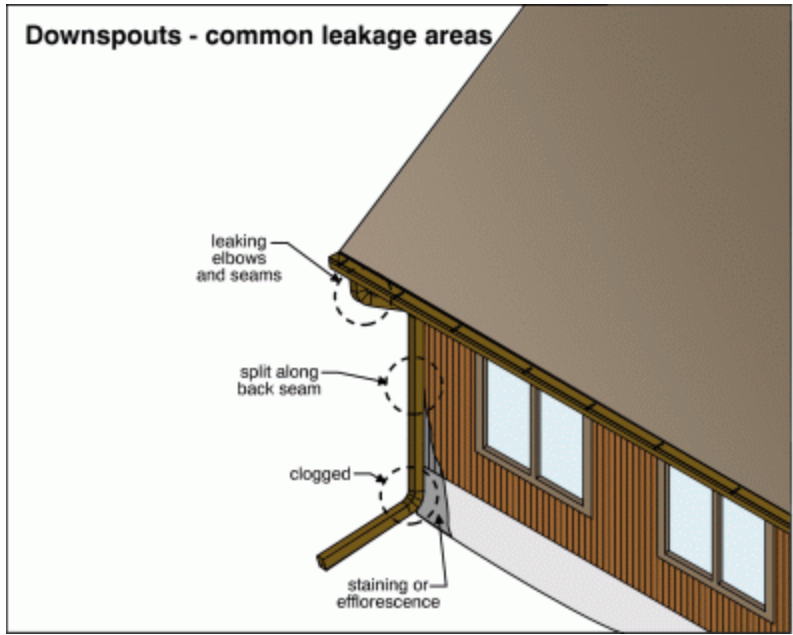
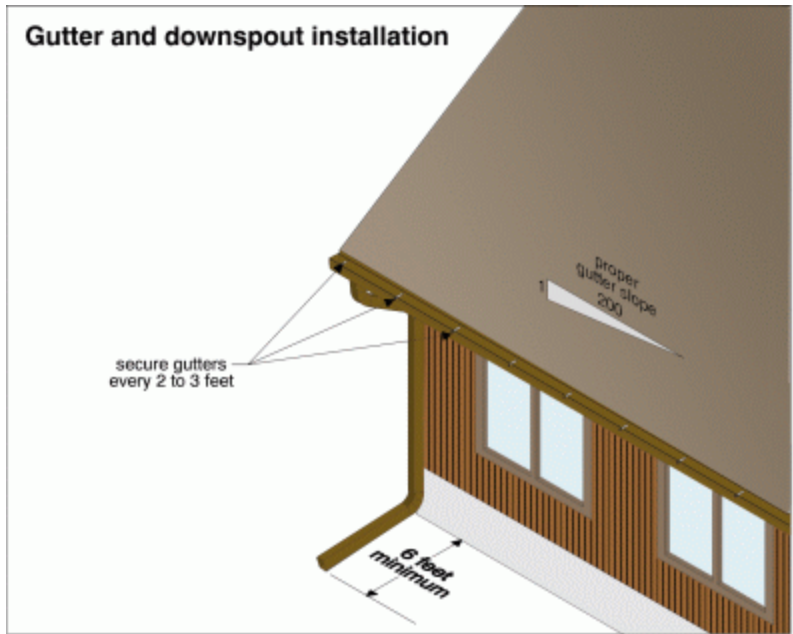
3. Condition: • [Missing](#)

Implication(s): Chance of water damage to contents, finishes and/or structure

Location: Southeast

Task: Provide

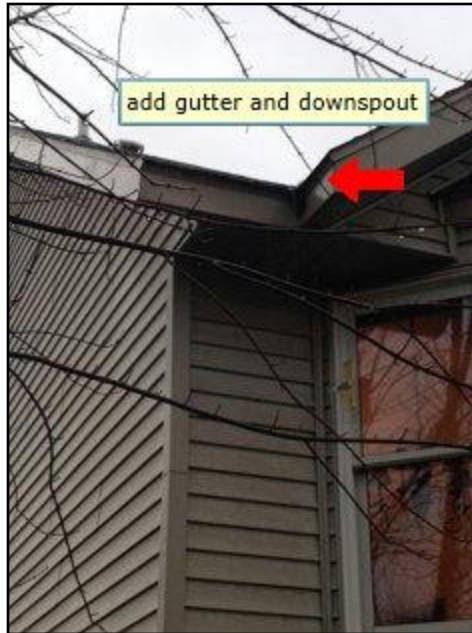
11. Missing

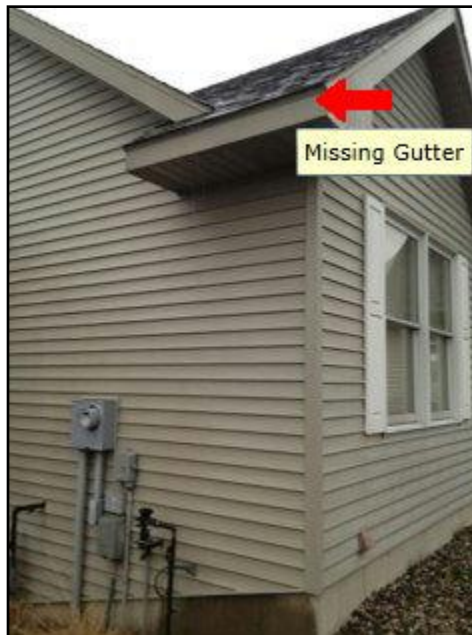
4. Condition: • [Missing](#)

Implication(s): Chance of water damage to contents, finishes and/or structure

Location: Northwest

12. Missing

Task: Provide

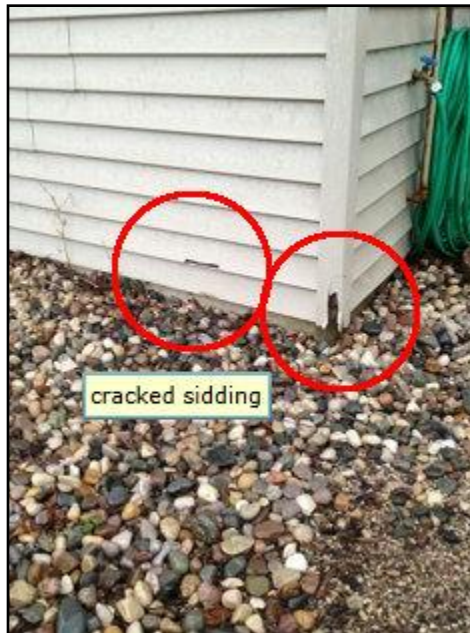
5. Condition: • [Mechanical damage](#)

Implication(s): Cosmetic defects | Chance of water damage to contents, finishes and/or structure

Location: Southeast

13. Mechanical damage

Task: Repair or replace

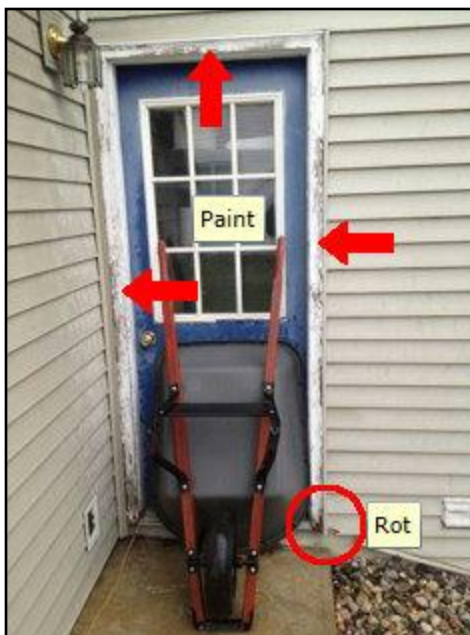
6. Condition: • [Rot](#)

Implication(s): Chance of damage to finishes and structure

14. Rot

Task: Repair

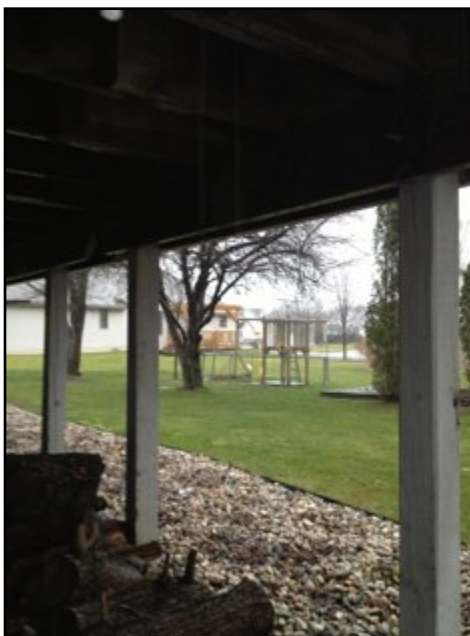
### 7. Condition: • [End support inadequate](#)

The Weight of the deck is being held up by one lag bolts per support. Licensed contractor to review and repair.

**Implication(s):** Weakened structure | Chance of movement

**Location:** Rear Deck

15. End support inadequate

**Task:** Improve
